Allison Creek Dam Removal & Stream Restoration

Christopher H. Roach
P.E., Consulting
Engineer

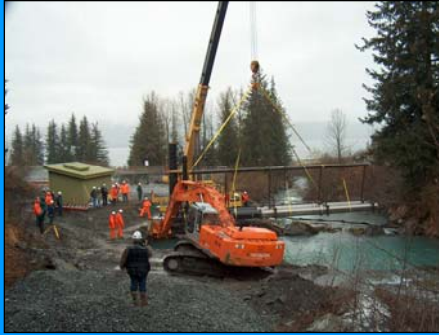
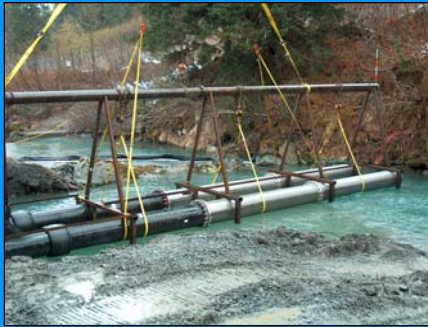
History

- In 2002 system began failing again – corrosion
- Replaced original system due to uncertainty about dewatering / tie-in
- Work done at low water – open cut – no diversion
- New intake screens placed with crane / suspension frame
- Condition of dam a concern during project – Stated concerns to Client

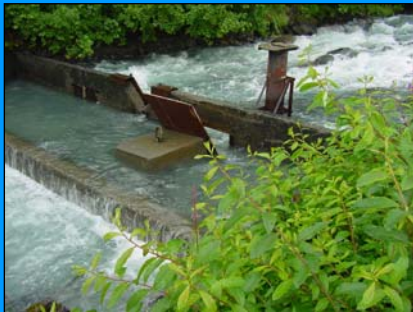
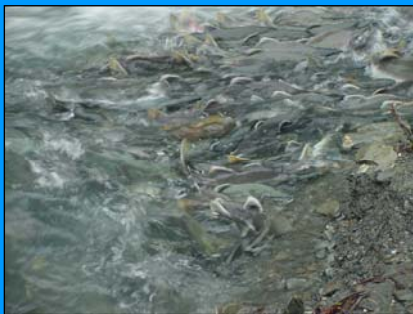
Dam Breach July 2003

- Undermining of Dam caused loss of sub grade & Dam Breach
- Stream flowed under dam
- Return run of salmon passed through under dam
- Emergency Repairs to plug breach
- Need for long term solution evident.

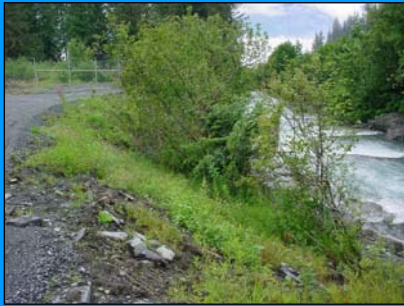
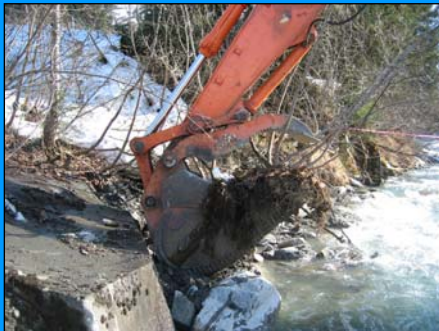
Construction

- Hydraulics at dam unacceptable for fish passage w/ floor in-place.
- Floor of dam and left abutment removed.
- Broke up with Hoe, working from center.
