Bringing the Bottom-Up: Restoring Floodplain Connectivity in Tepee Creek

Will Conley and Mike McAllister, P.E.

River Restoration Northwest
Stream Restoration Design Symposium
February 7, 2008

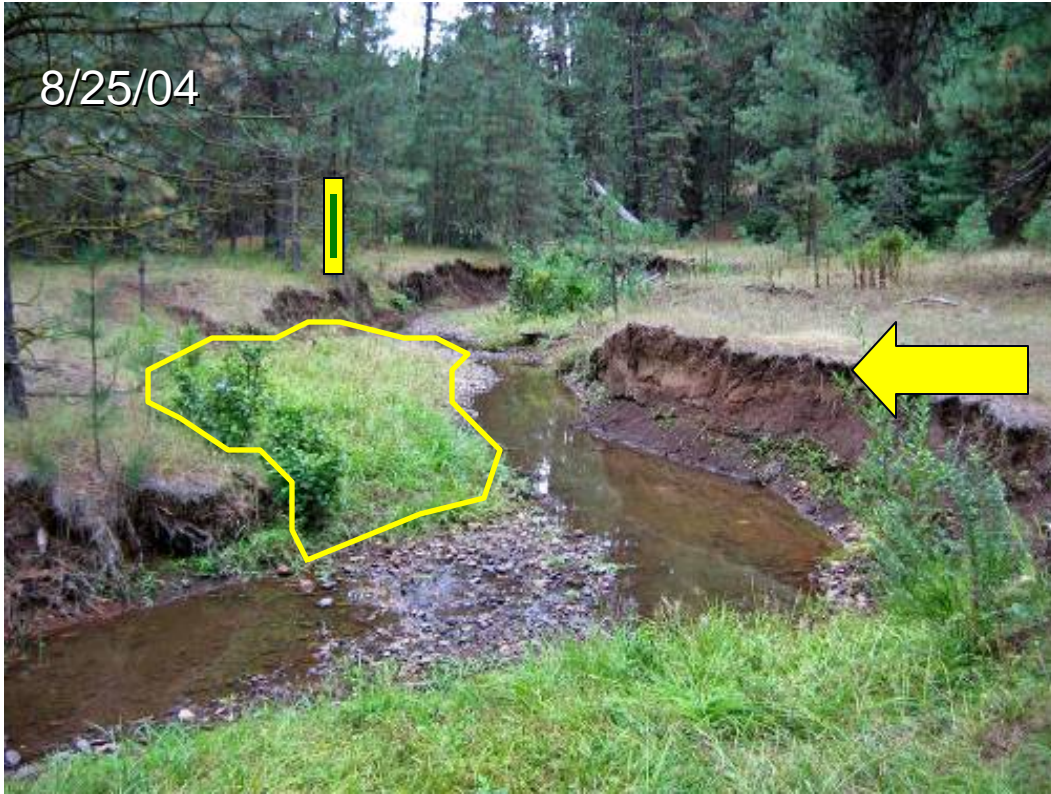
STA 10+80

Several locations within the reach showed signs of recovery prior to project

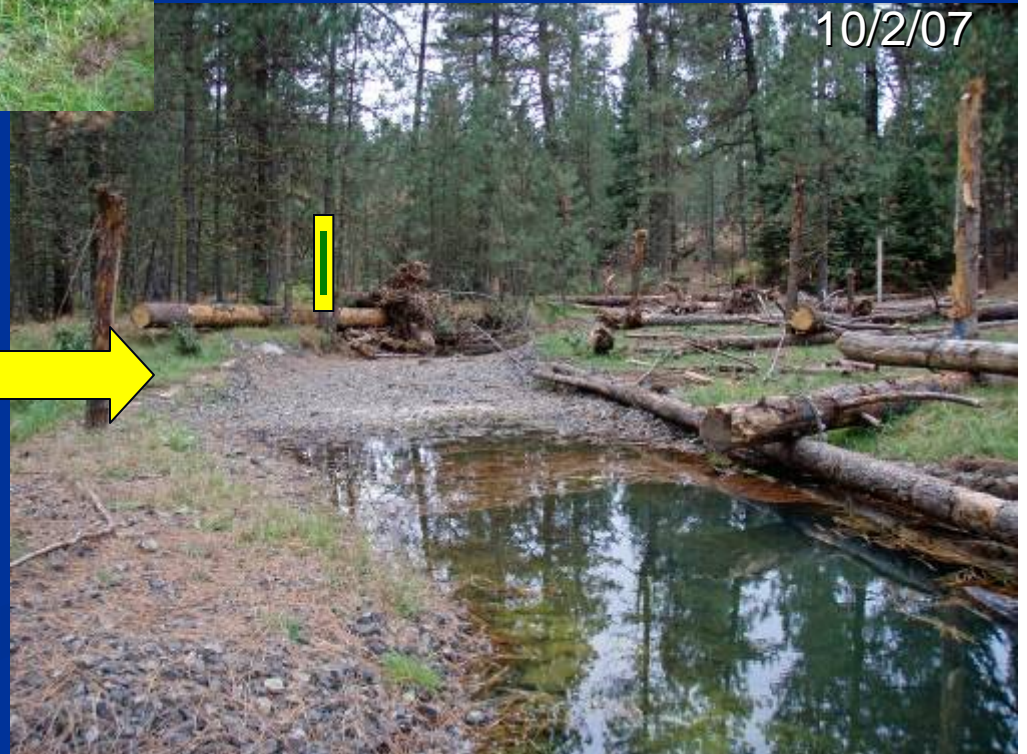
“Immature” cross-section constructed to minimize bed shear in near term and allow deposition to create inset channel

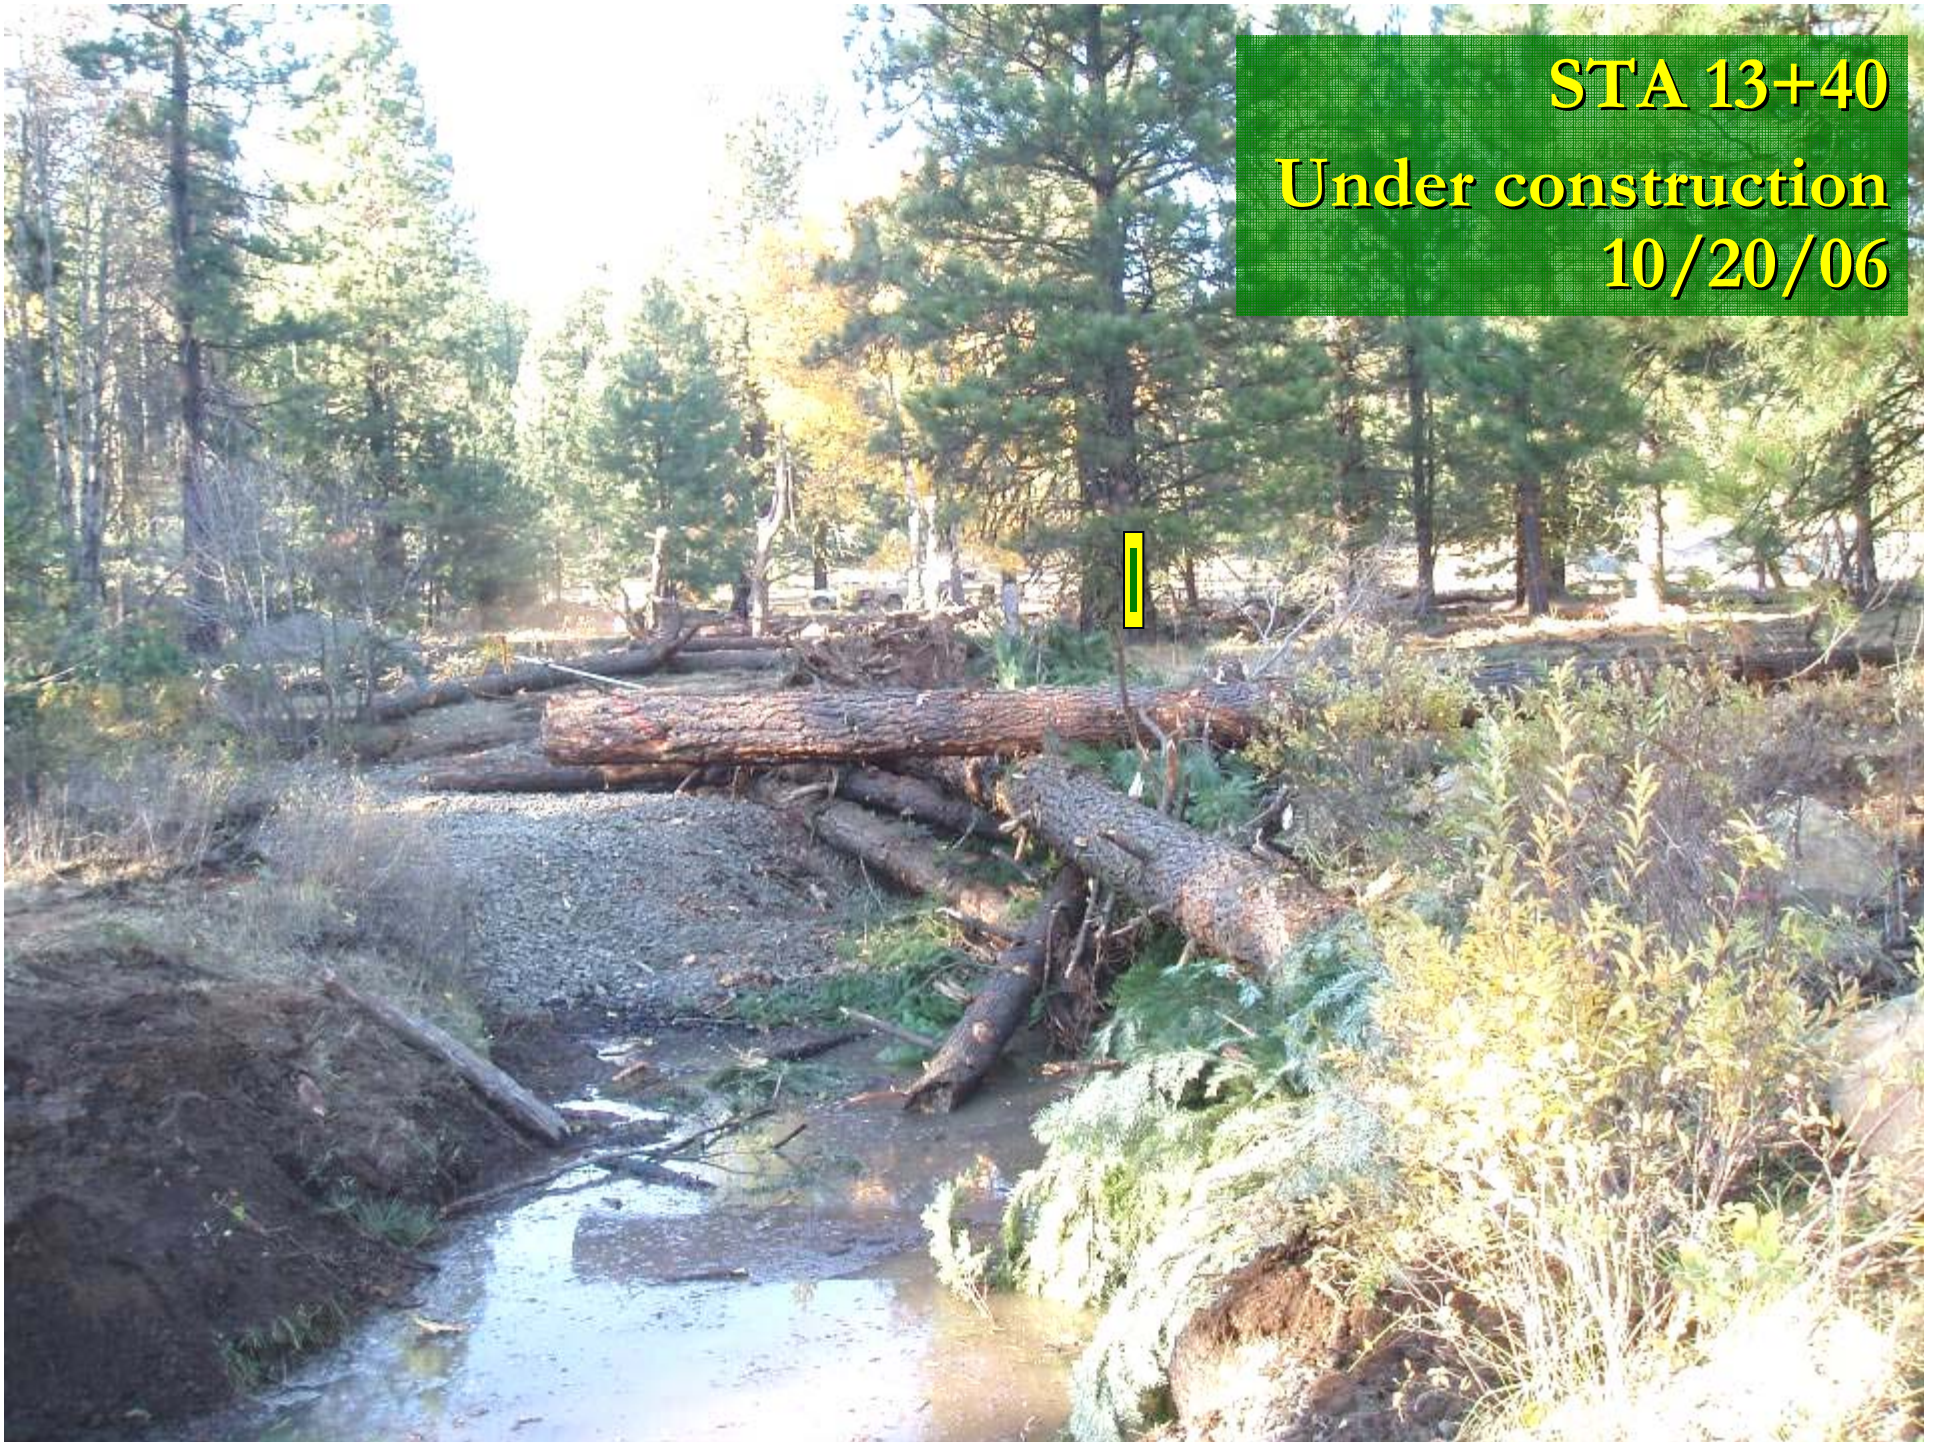
STA 13+40
Under construction
10/20/06

There's more than meets the eye....

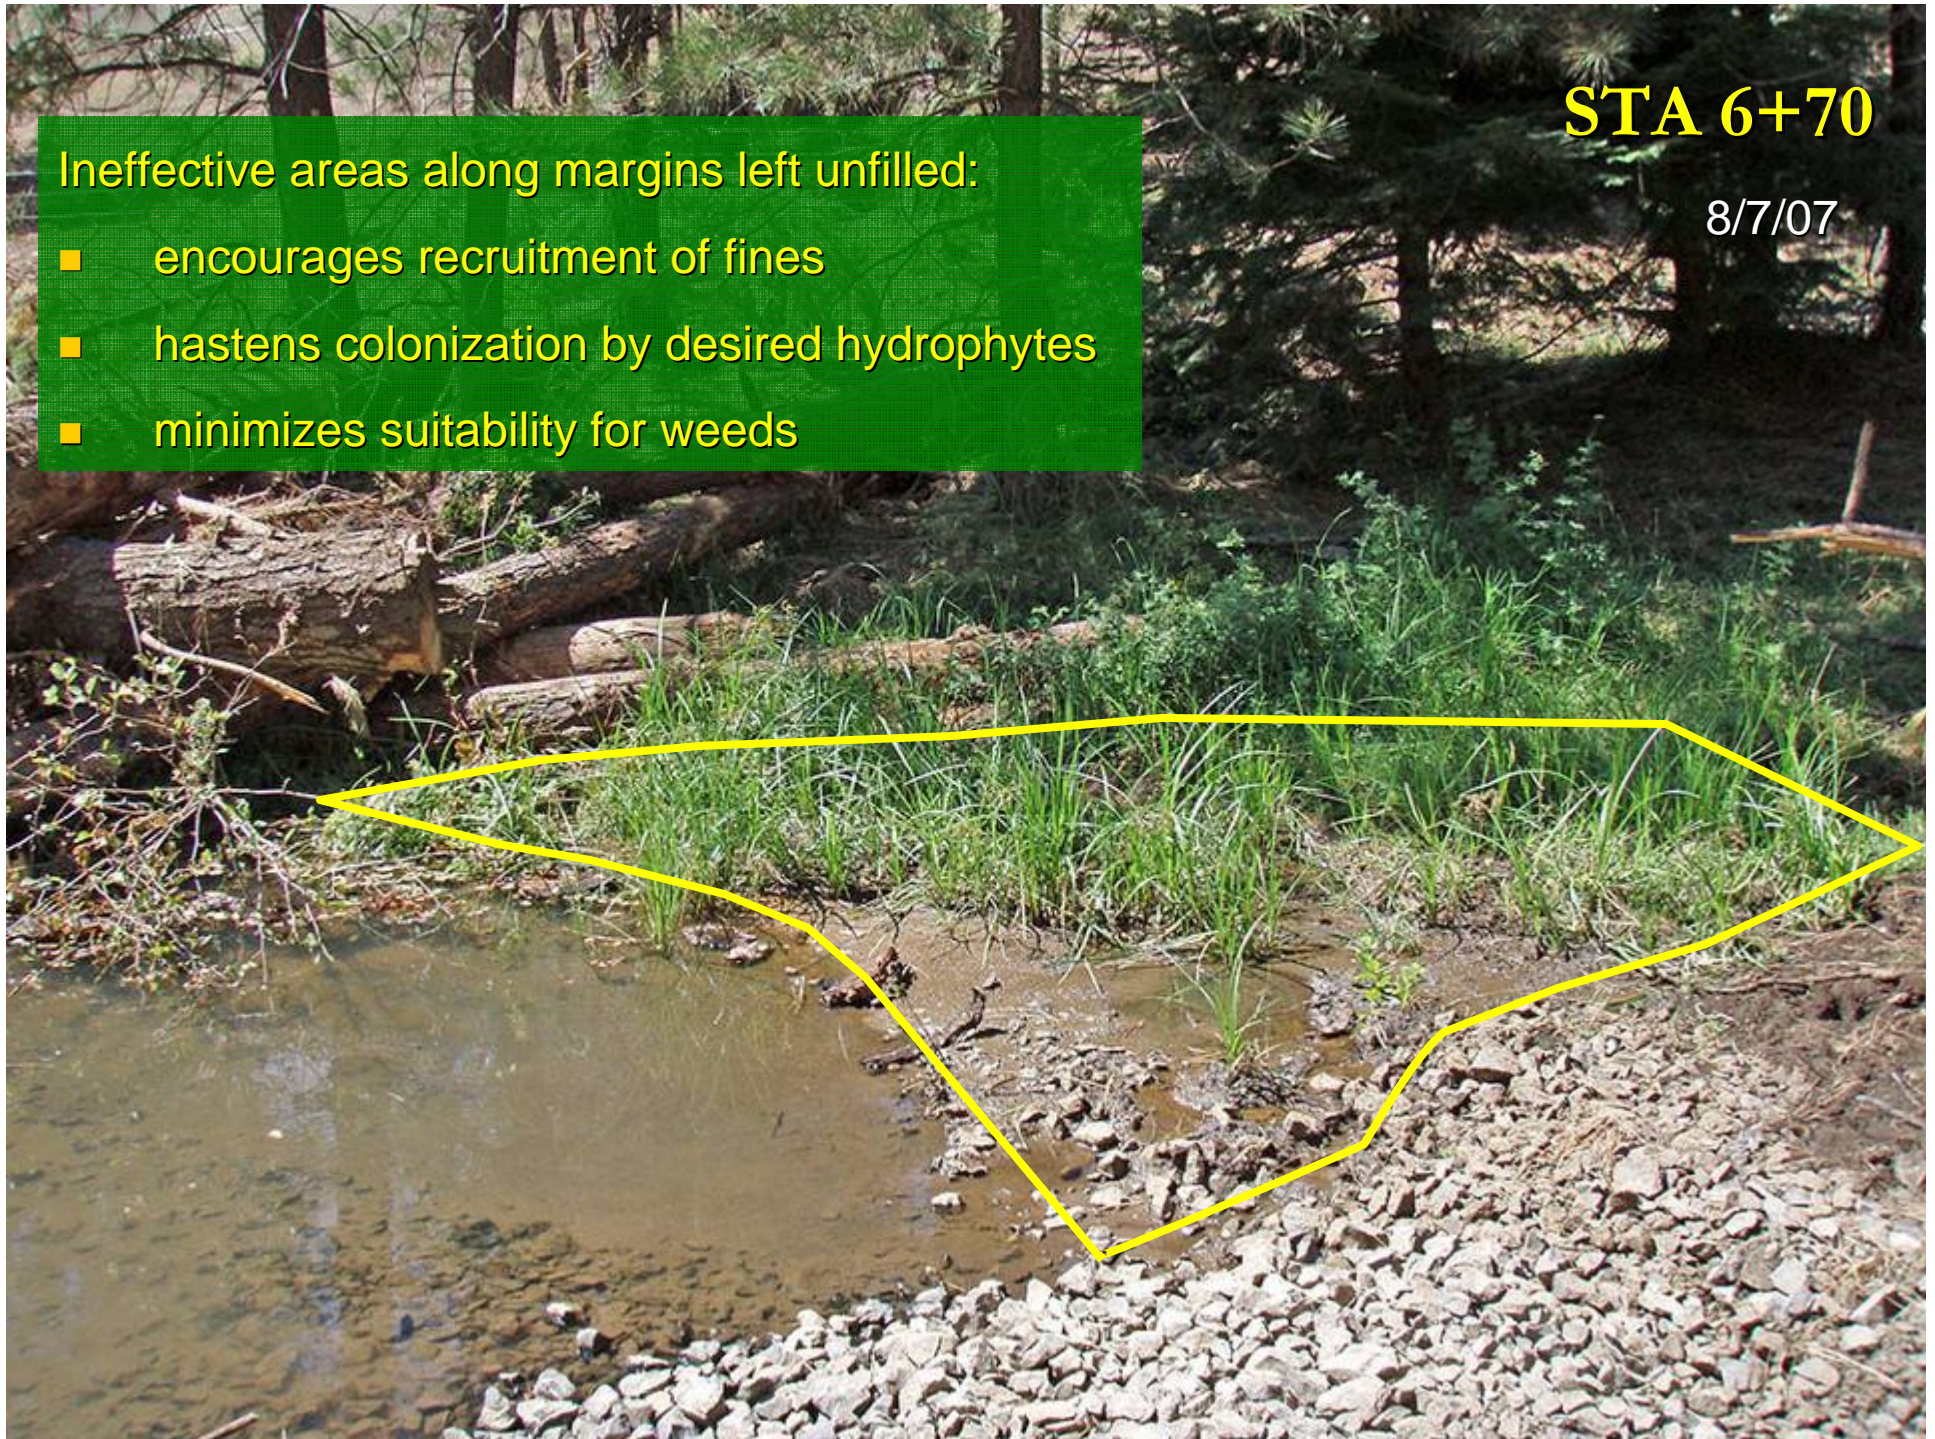
STA 6+70

Ineffective areas along margins left unfilled:

- encourages recruitment of fines
- hastens colonization by desired hydrophytes
- minimizes suitability for weeds

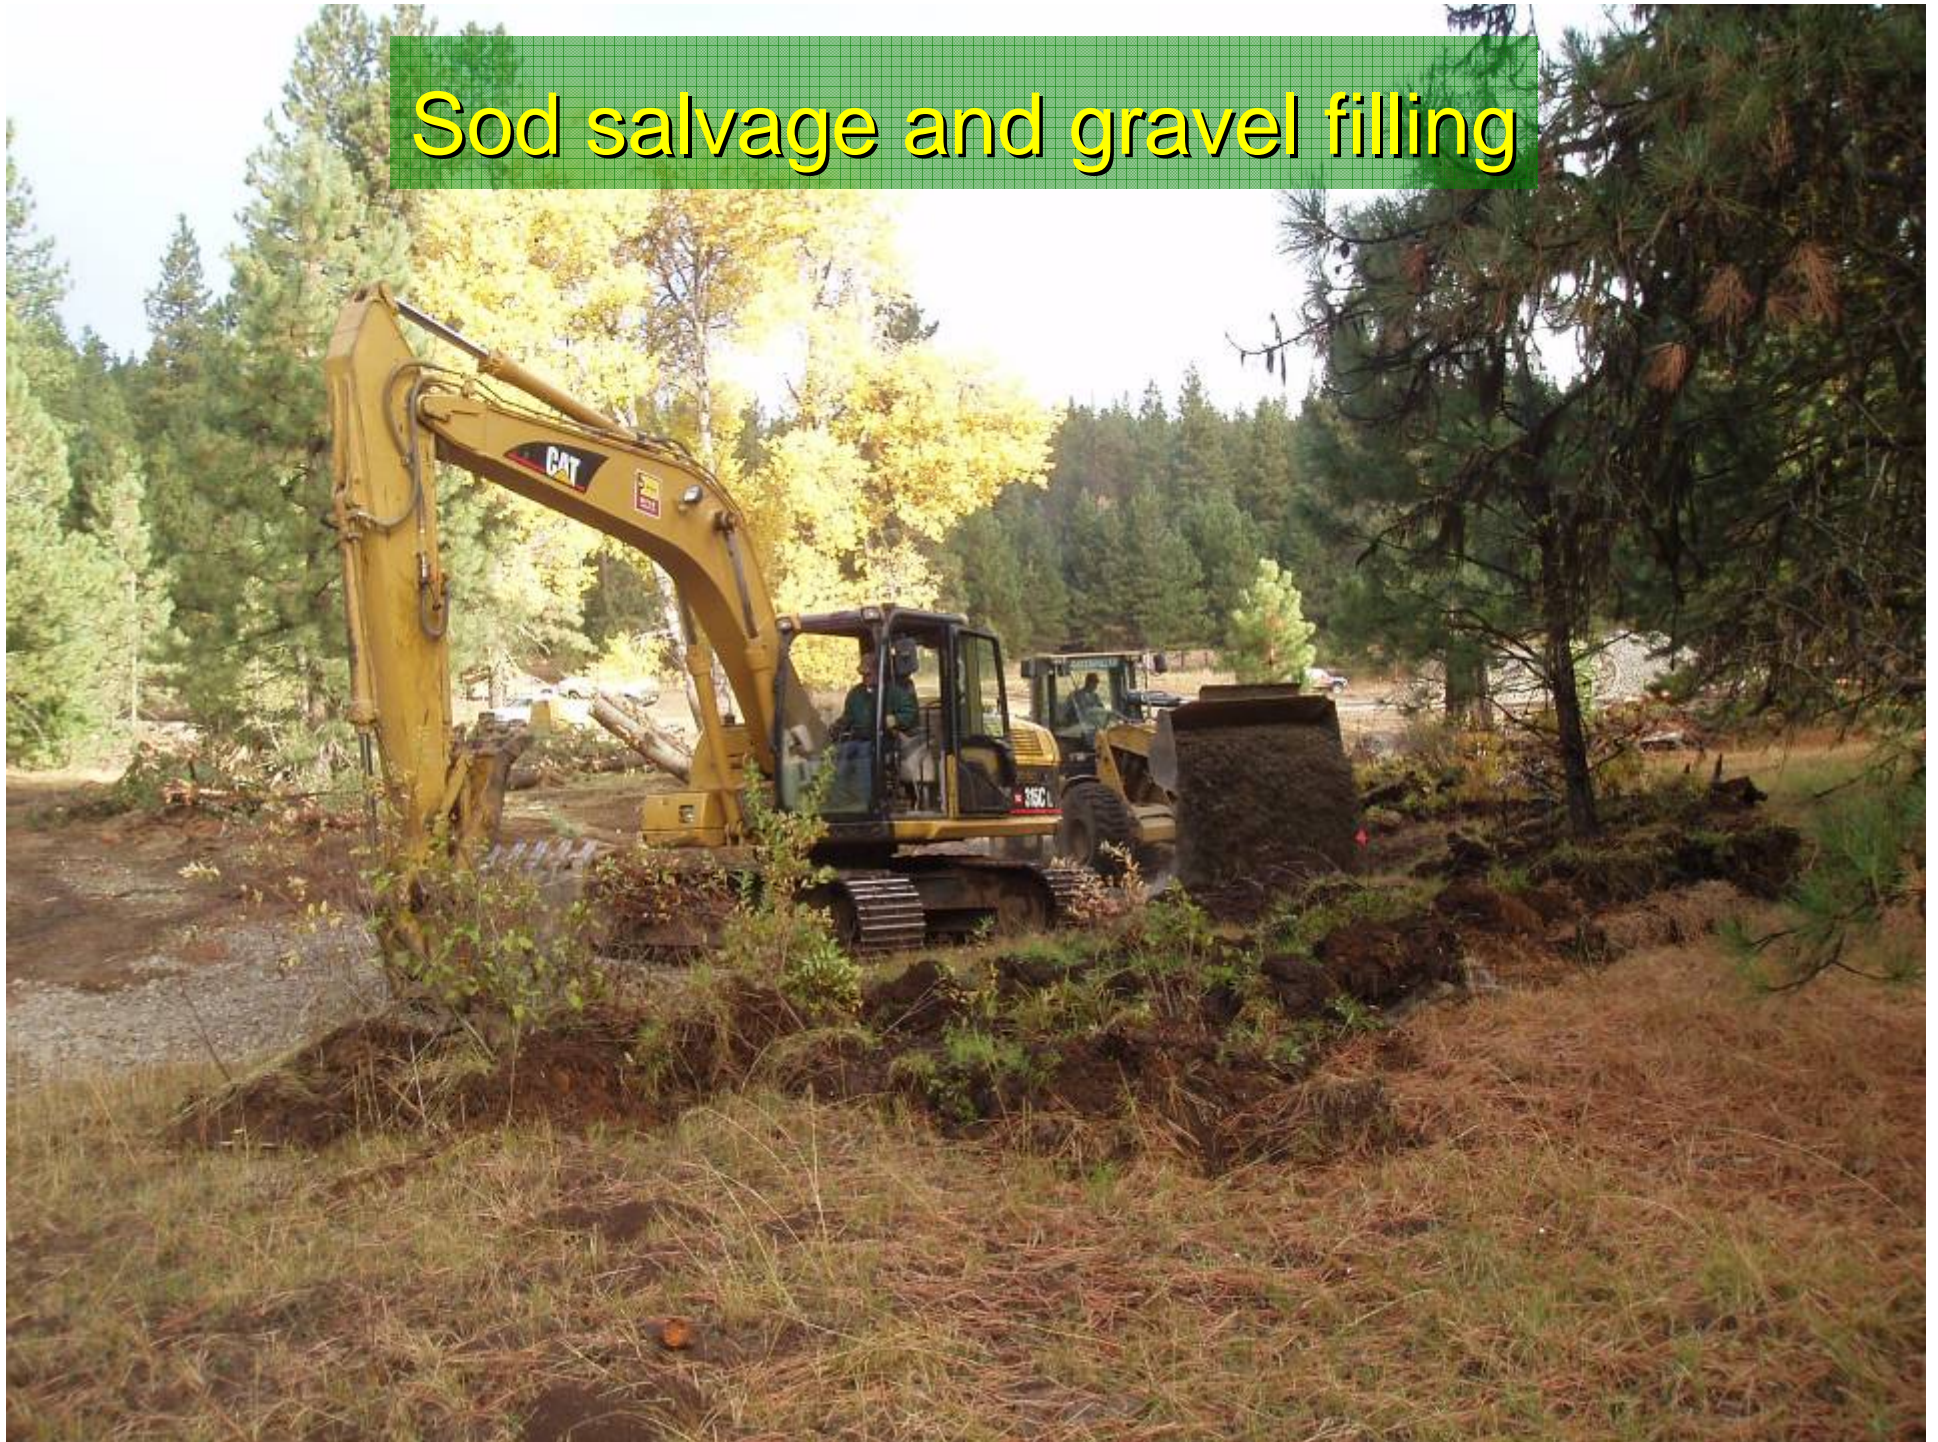
Sod salvage and gravel filling

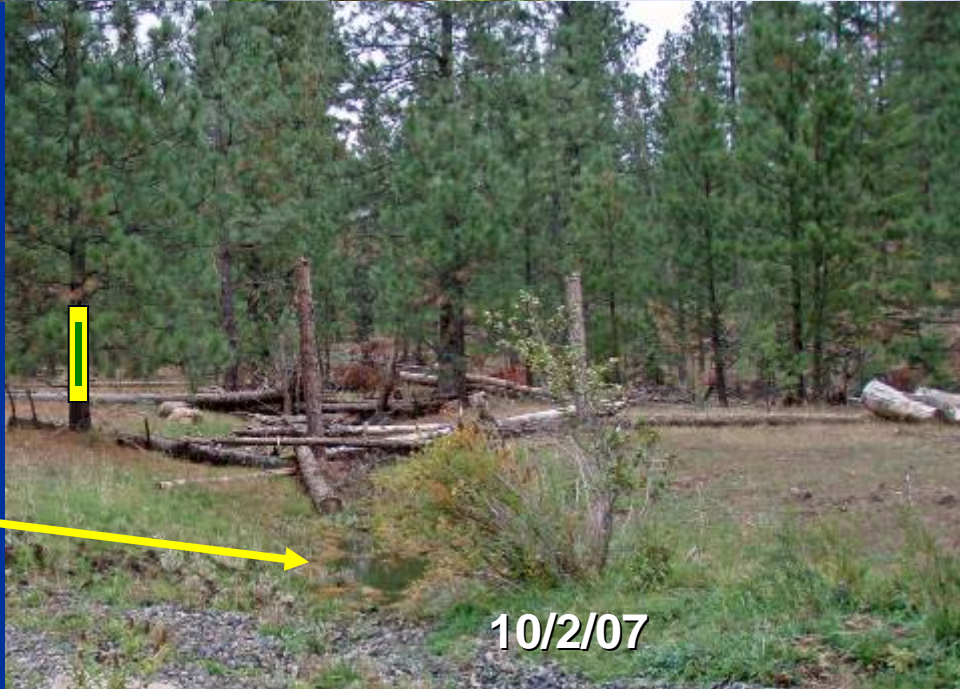
STA 12+80

Surface water maintained
through growing season

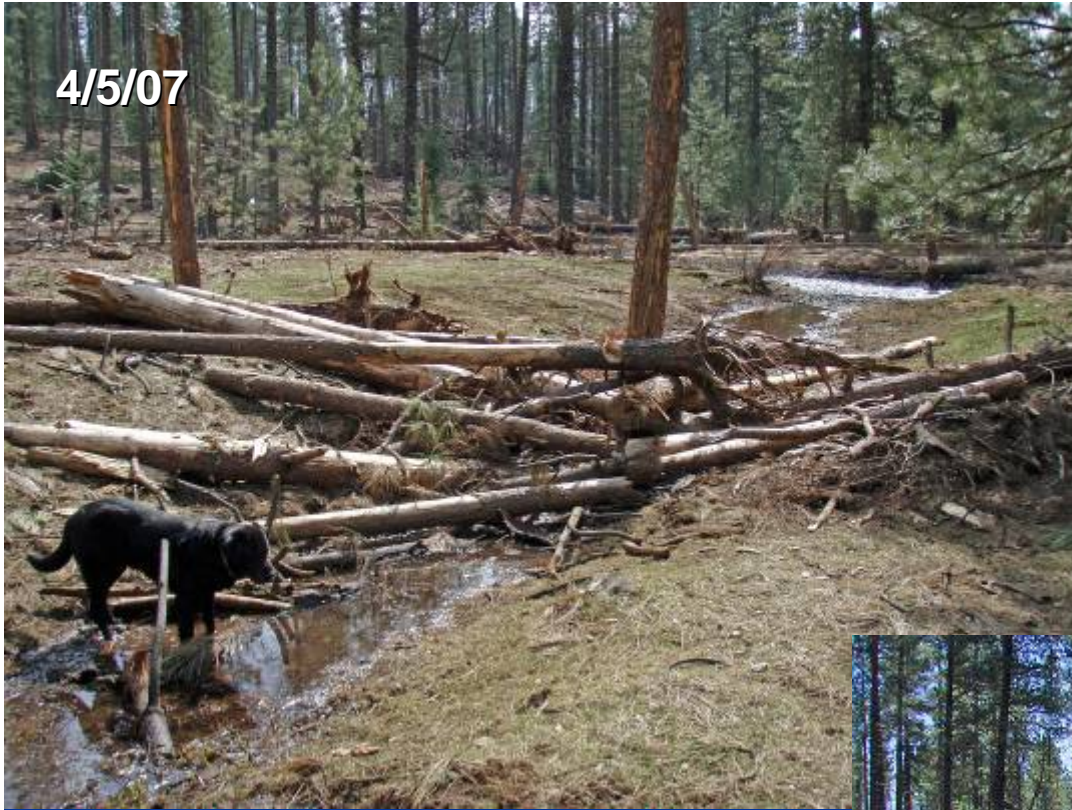
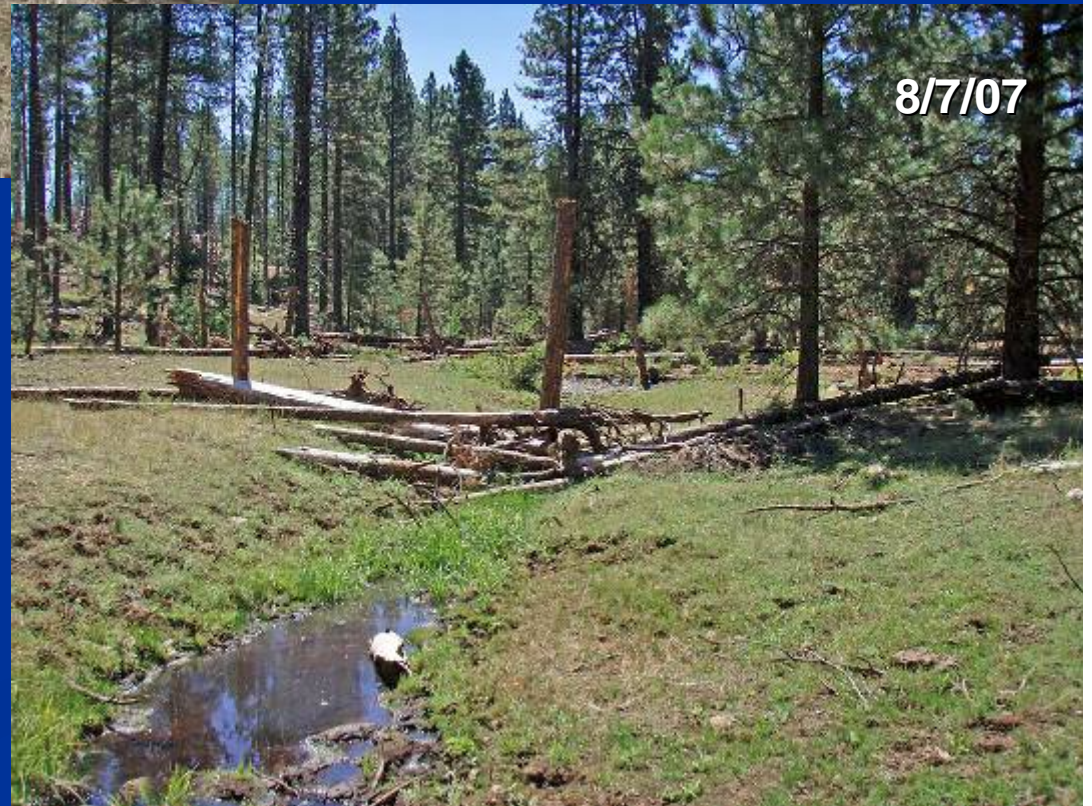
Jam 1

- Roughness to prevent capture
- Constructed to be porous

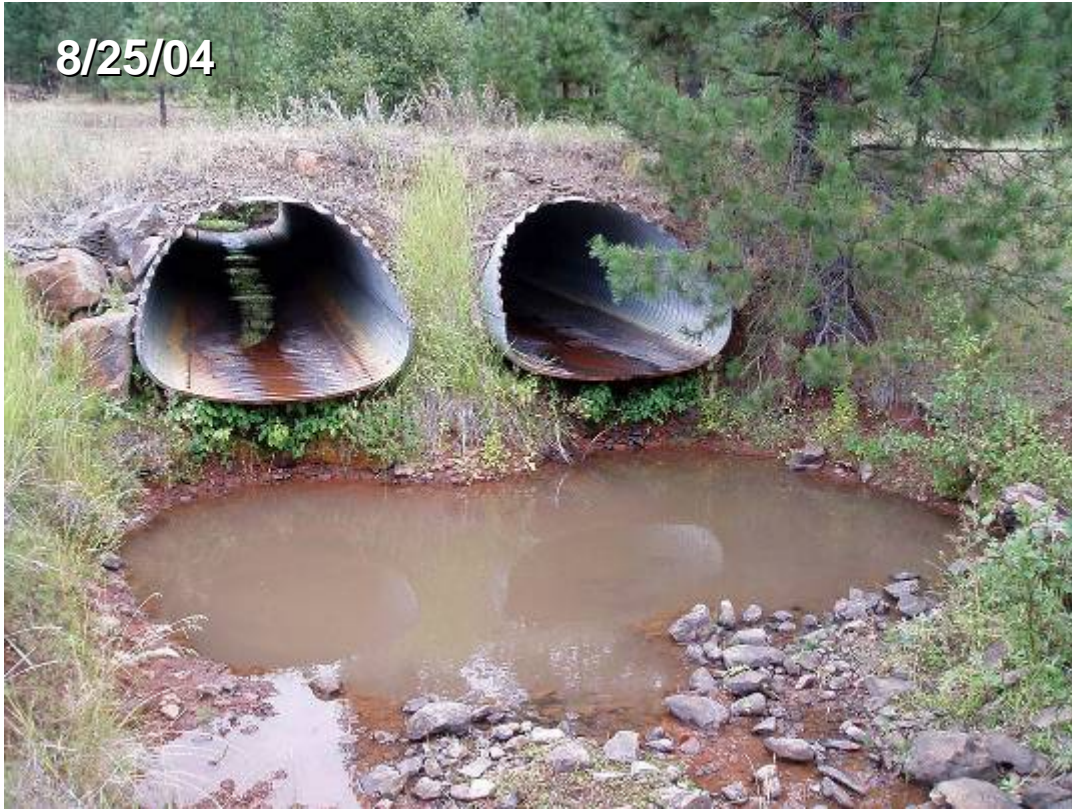
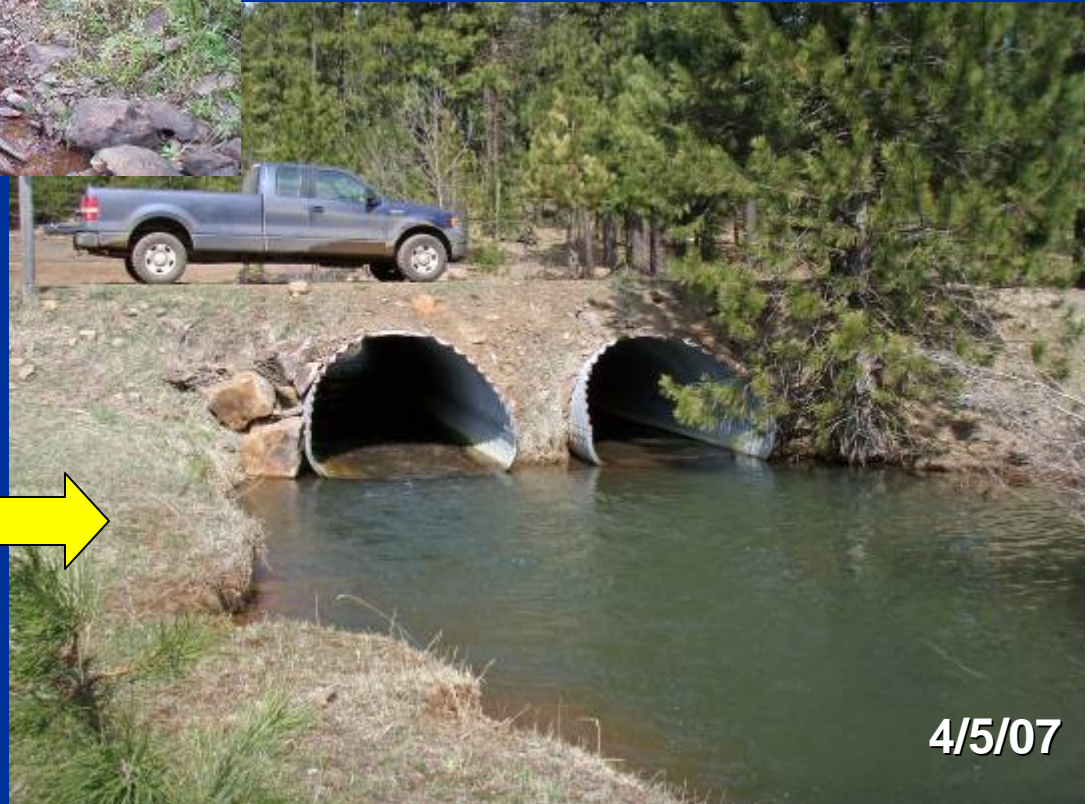
IXL Road Crossing (STA 20+90)

Culvert outlets backwatered to
improve fish passage

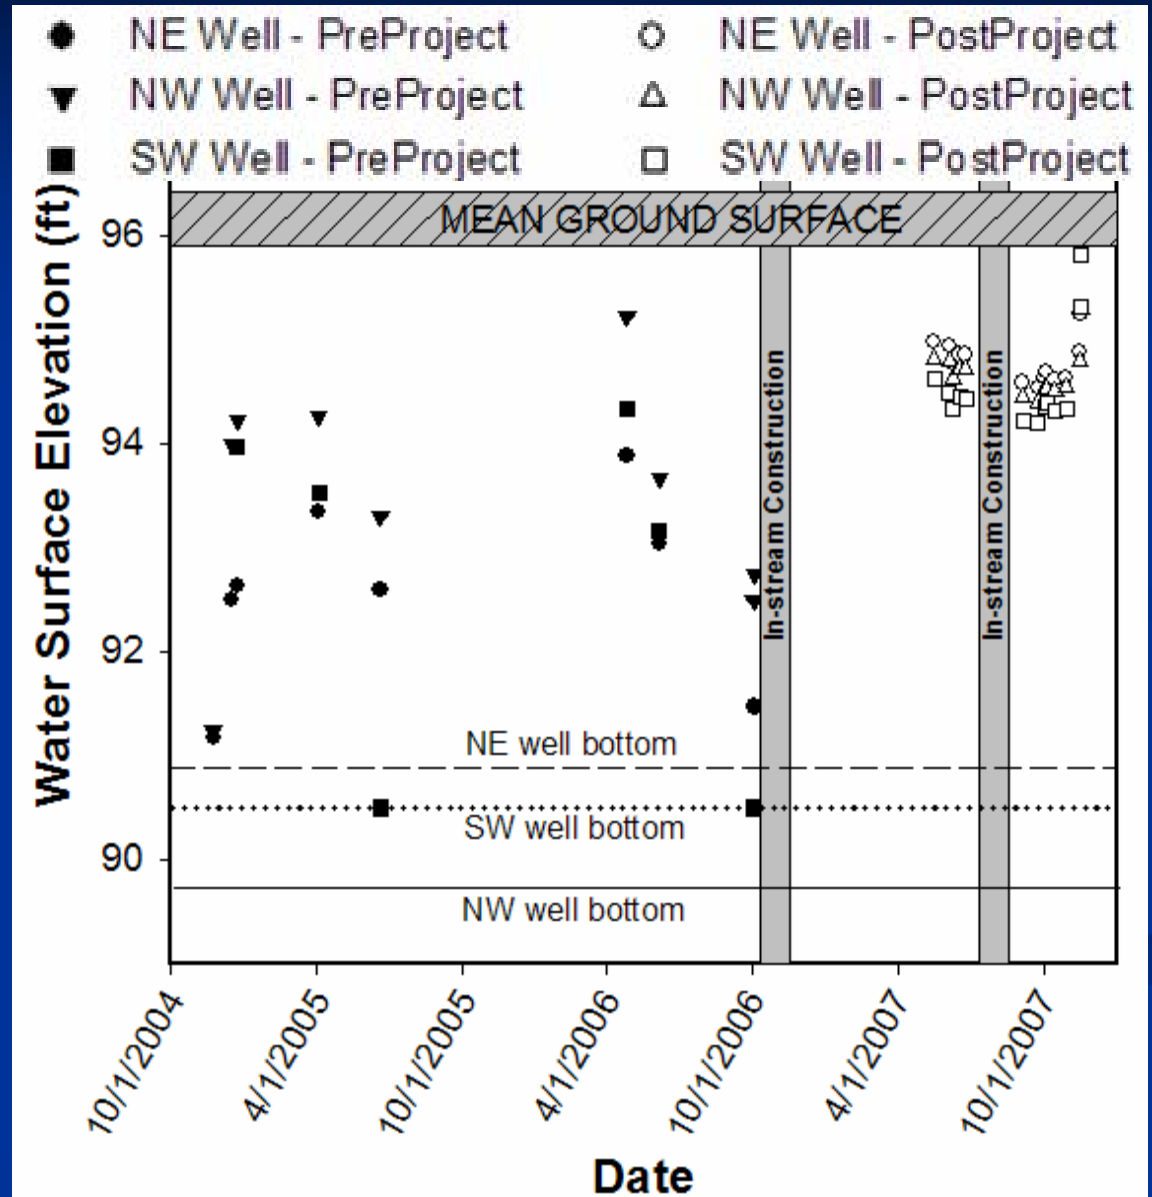
Groundwater Monitoring

- 2' – 4' increase in summer/fall water table
- 1.8' increase in the average annual water table
- Less variability between and amongst wells

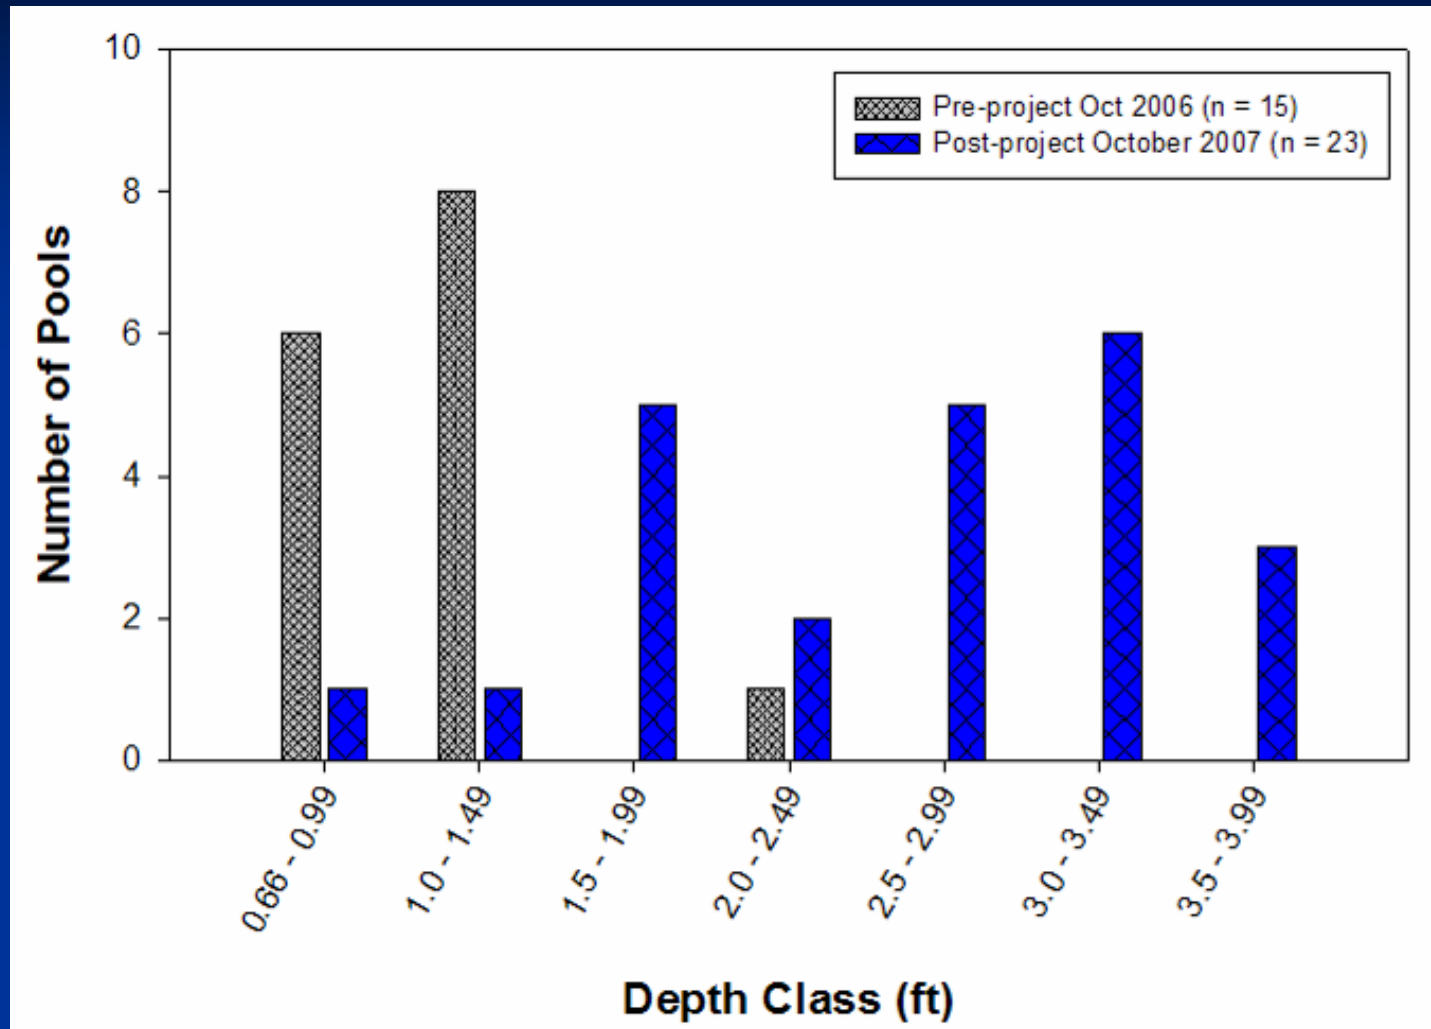
Residual Pool Depths

Note: because some pools were under-filled during construction, the median value for residual depths under equilibrium conditions is anticipated to be 2.0' - 2.49'
