Applying Effectiveness Monitoring Results to Refine Stream Restoration Design

Troy Brandt
Water Consulting, Inc.
Portland, Oregon

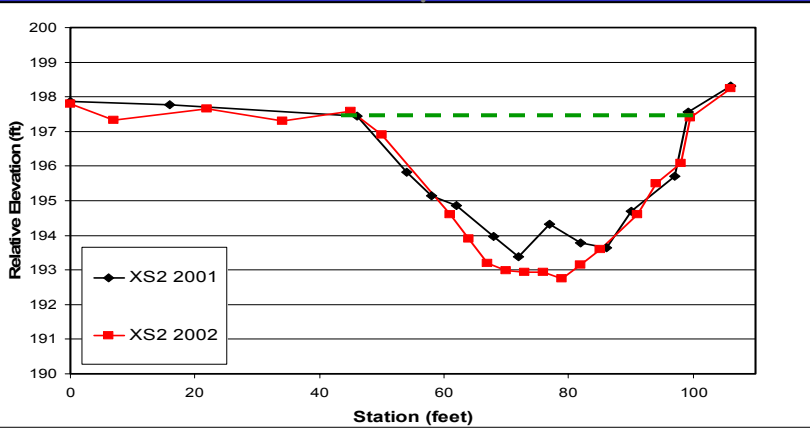
Grave Creek As-Built and First Year Survey Data

Width (ft)	Area (ft ²)	Mean Depth (ft)	Max Depth (ft)	W/D
As-Built	53	138	2.6	4.1	20
Year 2002	55	163	3.0	4.8	18

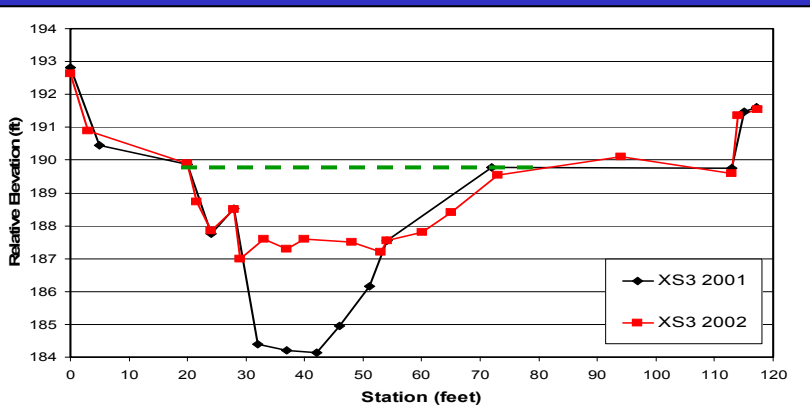
Grave Creek As-Built and First Year Survey Data

Width (ft)	Area (ft ²)	Mean Depth (ft)	Max Depth (ft)	W/D
As-Built	52	154	3.0	5.7	18
Year 2002	64	107	1.7	2.9	38

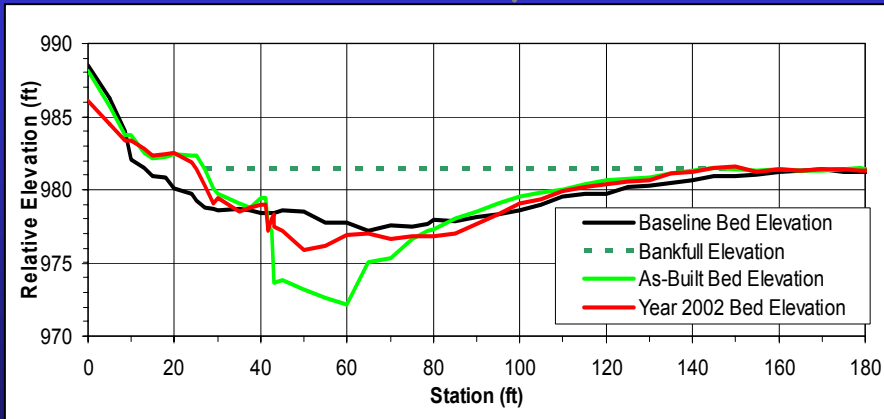
Boulder River As-Built and First Year Survey Data

Width (ft)	Area (ft ²)	Mean Depth (ft)	Max Depth (ft)	W/D
As-Built	120	488	4.1	10.1	30
Year 2002	120	339	2.8	5.5	43

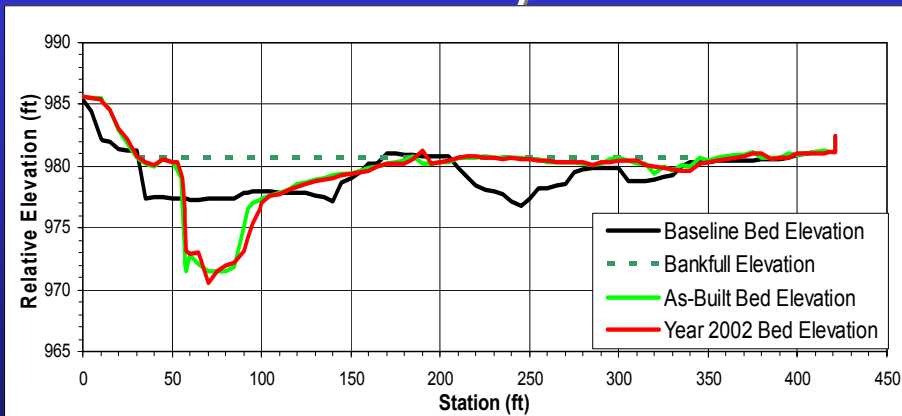
Boulder River As-Built and First Year Survey Data

Width (ft)	Area (ft ²)	Mean Depth (ft)	Max Depth (ft)	W/D
As-Built	155	471	3.0	9.3	51
Year 2002	155	500	5.2	10.2	48

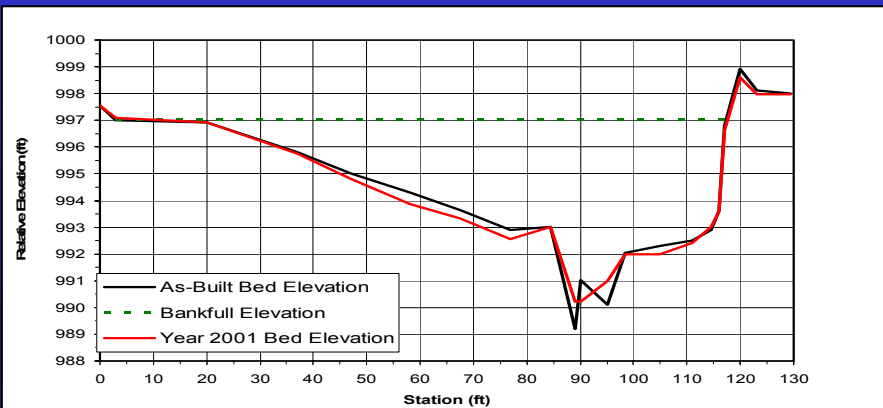
Swan River As-Built and First Year Survey Data

Width (ft)	Area (ft ²)	Mean Depth (ft)	Max Depth (ft)	W/D
As-Built	114	314	2.8	7.8	41
Year 2002	114	332	2.9	6.9	39

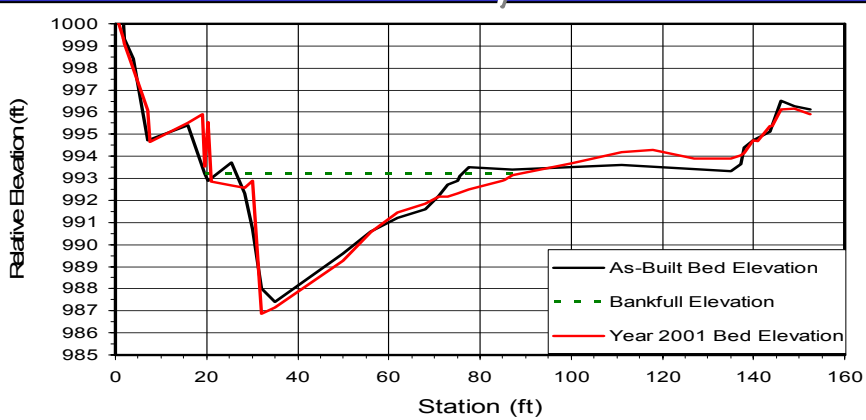
Swan River As-Built and First Year Survey Data

Width (ft)	Area (ft ²)	Mean Depth (ft)	Max Depth (ft)	W/D
As-Built	58	150	2.6	5.7	23
Year 2002	74.5	183	2.5	6.7	30
