Fifteenmile Creek Fish Passage Improvements at Channel Obstacles

Janet Corsale, Greg Koonce & Jason Smith
February 3, 2004

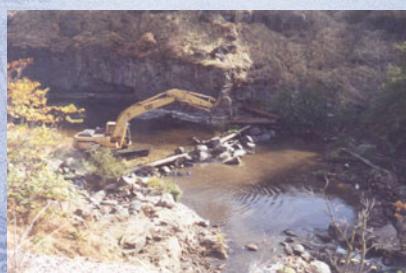
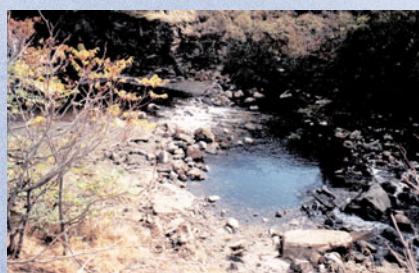
Natural Channel Alternative

Before

After

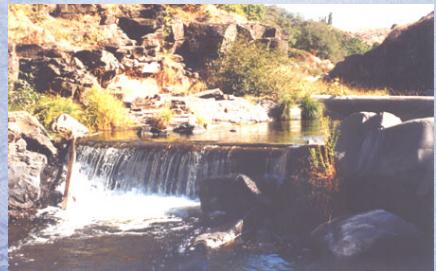
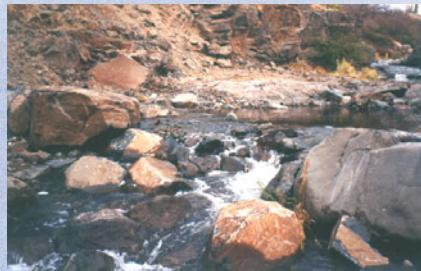
Natural Channel Alternative

Before

After

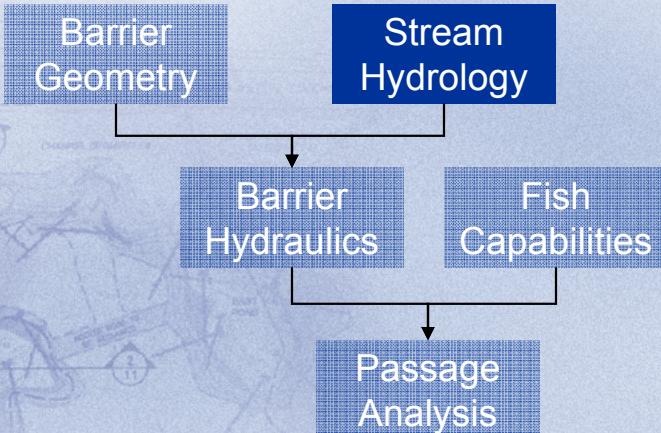
Barrier Analysis

Powers & Osborne (1985)

Stream Hydrology

- **Migration Period (Feb-Apr 2001)**
- **Flows**
 - 21 cfs, measured 2001
 - 93 cfs, Q80% (OWRD)
 - 178 cfs, Q10% (ODFW passage criteria)

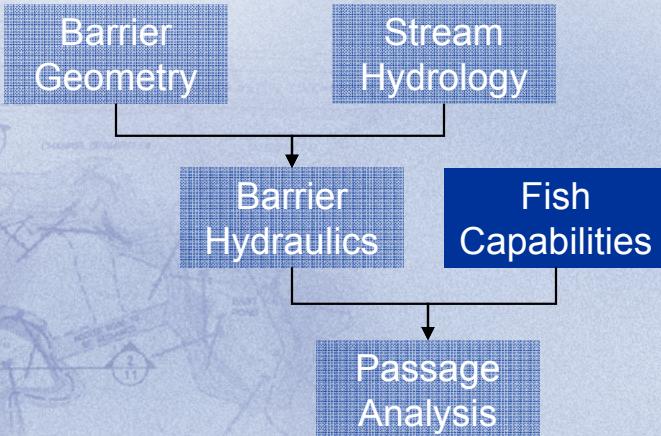
Barrier Analysis

Fish Capabilities

Powers & Osborne (1985)

burst speed x fish condition coefficient = swim speed

- 19.9 ft/s, 5 sec
- 10.3 ft/s, 10 sec

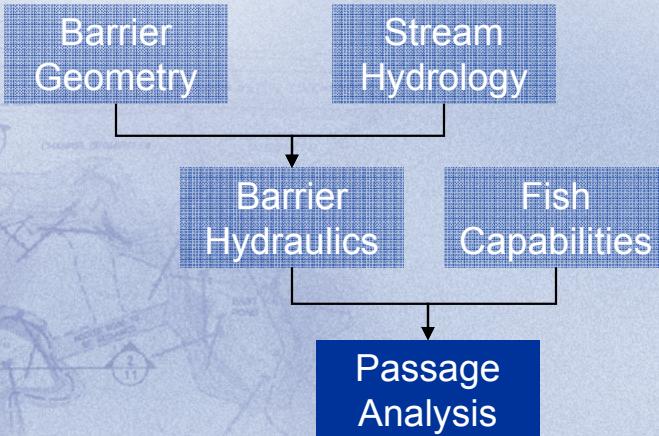
Barrier Analysis

Passage Analysis

Step 1: Jump or Swim?

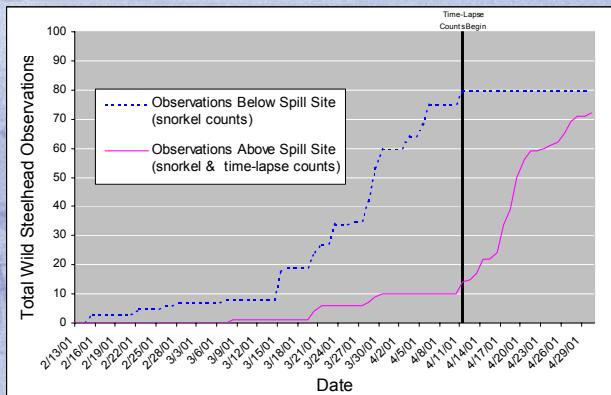
- Installed time-lapse video monitoring station on April 11th.
