## Dam Removal in the North Clackamas Urban Area

### *Project History, 1960- 1996*

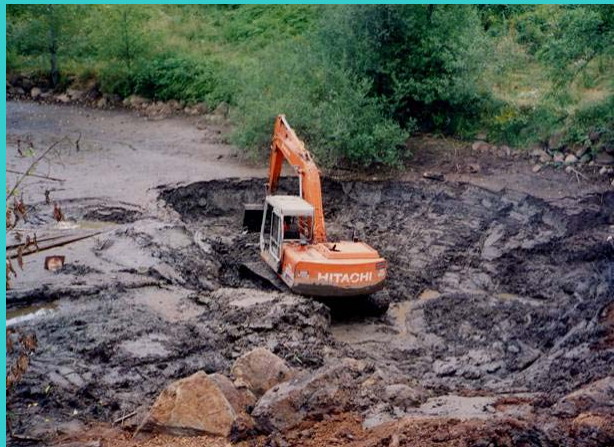
## *Excavation*

Sediment plan was to excavate a channel from the approximate centerline of the pond, and to place the excavated material in the surrounding uplands to create 3:1 bank slopes and riparian area. No sediment was hauled off the project site.

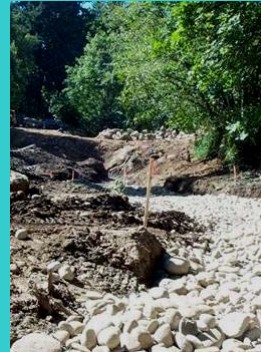
Grade: average 4.5%  
Cross Section Width: 20 feet (6-8-6)  
Materials: LWD, Boulder, Cobble,  
gravel of various sizes
