Allison Creek Dam Removal & Stream Restoration

Christopher H. Roach
P.E., Consulting
Engineer

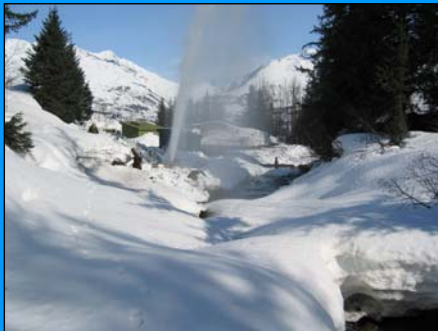
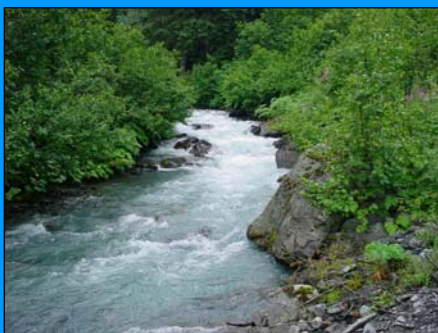
- Undermining of Dam caused loss of sub grade & Dam Breach
- Stream flowed under dam
- Return run of salmon passed through under dam
- Emergency Repairs to plug breach
- Need for long term solution evident.

- Repair – plug hole and reinforce DS Channel
- Remove Dam & Restore Stream (Selected)
- Sedimentation U.S. of dam causing problems with intake.
- Dam was nearly complete blockage to migration
- Local concern was spawning over intakes, water quality

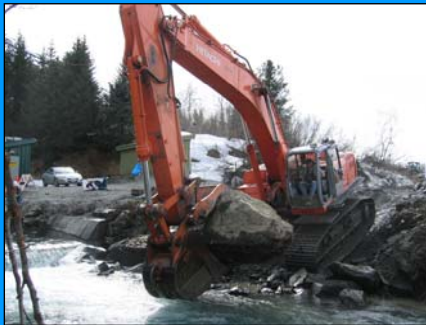
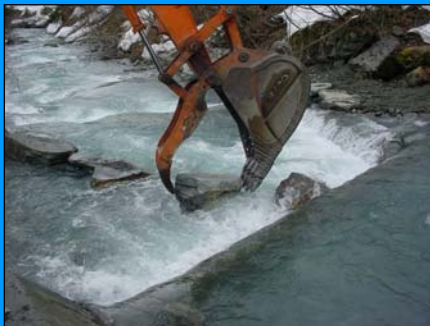
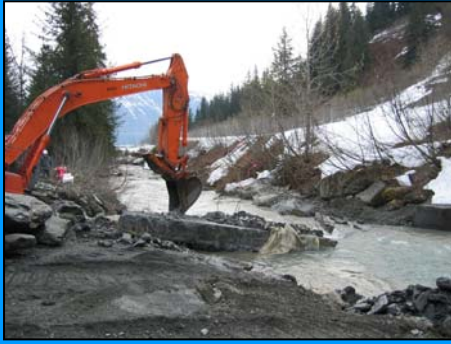
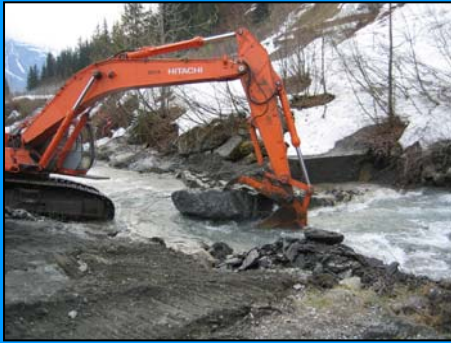
- Hydraulics at dam unacceptable for fish passage w/ floor in-place.
- Floor of dam and left abutment removed.
- Broke up with Hoe, working from center.

- Sill structures D.S. and U.S. installed first
- Structures constructed from D.S. toward U.S. end
- Worked from bank toward center of channel
- Worked in-stream due to local constraints
- Dam removed after grade re-established downstream
- First removed back-wall and built all structures to dam
- Removed floor and left abutment due to unacceptable hydraulics (fish passage)

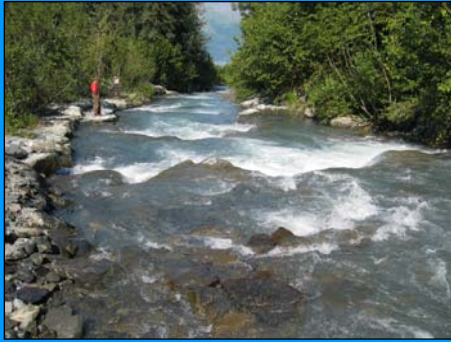
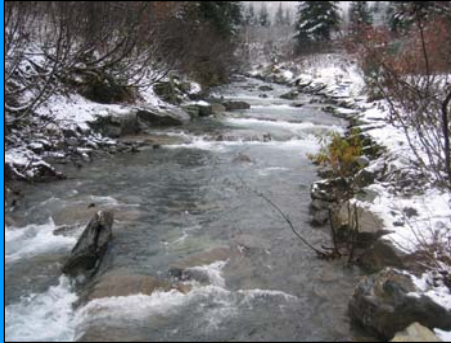
- Monitoring Survey deferred to Spring 2005
- Walk-downs conducted July 04, September 04, October 04
- Fish Passage Restored to upper channel
- 1 rock moved from lower structure.
- Revegetation highly successful
