Applying Effectiveness Monitoring Results to Refine Stream Restoration Design

Troy Brandt
Water Consulting, Inc.
Portland, Oregon

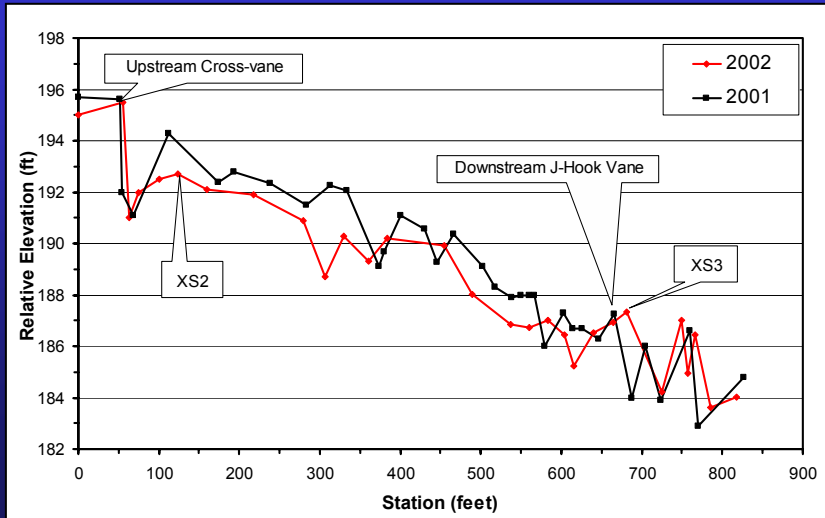
Grave Creek As-Built and First Year Survey Data

- Project Benefits -
 - Bank erosion reduced as designed
 - Improved fish habitat
 - Long-term channel stability through revegetation effort
- Project Problems -
 - Vertical channel stability issues
 - Sediment transport through some pools

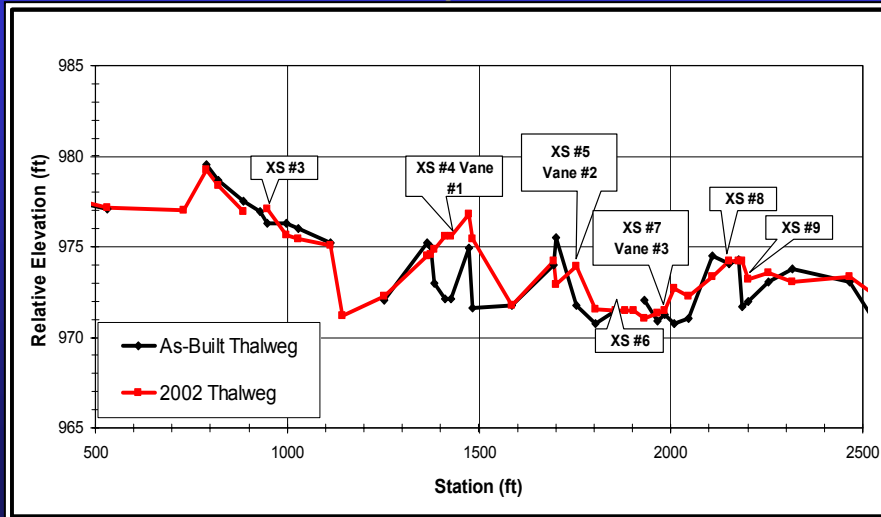
Boulder River As-Built and First Year Survey Data

- 💧 Project Benefits -
 - Terrace erosion reduced as designed
 - Improved fish habitat
 - Long-term channel stability through revegetation effort and channel shaping
- 💧 Project Problems -
 - Vertical channel stability issues
 - Sediment transport through pools
 - Failed bank stabilization structures

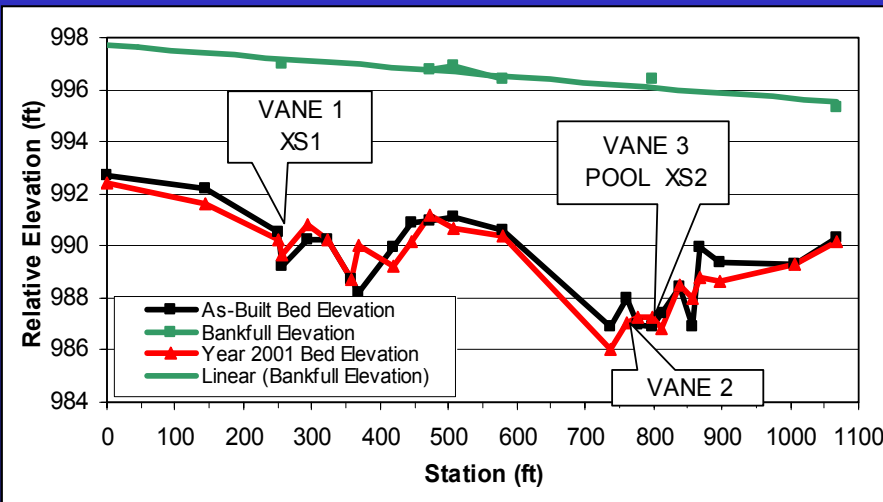
Swan River As-Built and First Year Survey Data

- Project Benefits -
 - Plugged and revegetated avulsion
 - Improved fish habitat
 - More stable channel plan form
 - Buffered eroding terrace
- Project Problems -
 - Minor bank erosion
 - Continued risk from upstream bridge
