Step-Pool Creation to Restore Fish Passage and Riparian Health

Project Background

- Reconstructing Utah Forest Highway 39 through Fishlake National Forest
- Led by FHWA in cooperation with Sevier County and the U.S. Forest Service

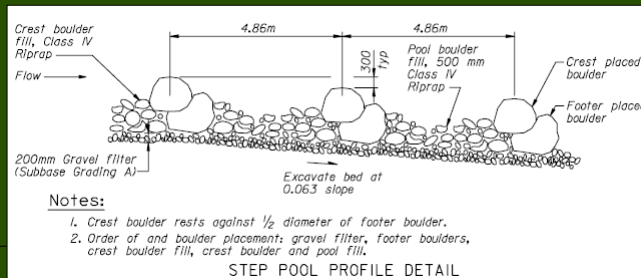
Design Details - Step-Pool Reach

- Final proposed configuration:
 - 9 crests / 8 pools over the 40-meter reach
 - Pool spacing of 4.9 meters
 - 0.3-meter elevation drop from pool-crest to pool-crest

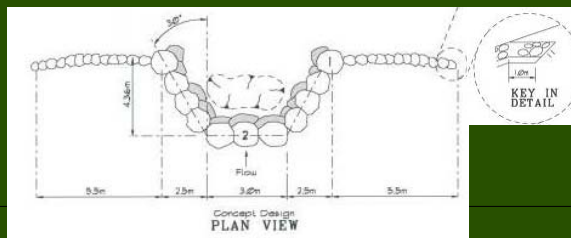
Design Details - Step-Pool Reach

- Final proposed configuration:
 - Boulder structures extend to the bankfull (1.5-year return interval discharge) stage elevation
 - Extend rock sill or key up to 2-feet above the 100-year discharge

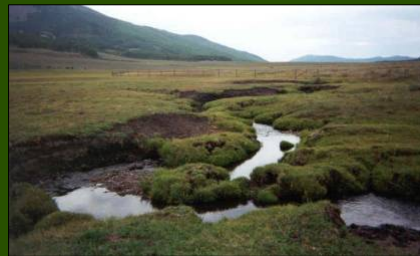
Mitigation Wetlands

- Required to compensate for road realignments and several crossings of Gooseberry Creek
- Mitigation site is degraded reach upstream from culvert
 - Livestock grazing
 - Downstream undersized culvert

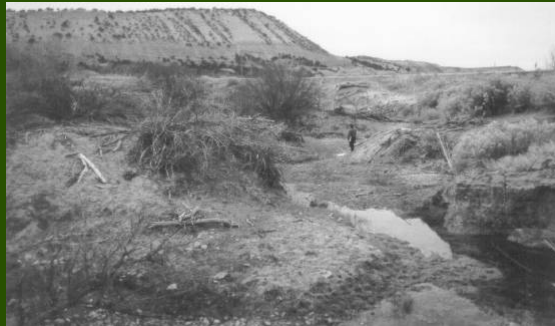
Design Details - Mitigation Wetlands

- Channel Characteristics
 - E5 Rosgen stream type
 - Bank Failure

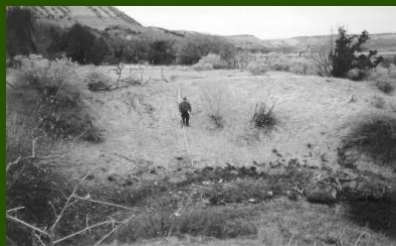
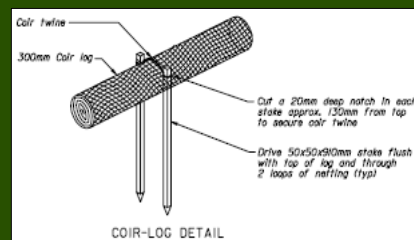
Design Details - Mitigation Wetlands

- Bank Protection
 - ~198 meters of shoreline protected using local willow cuttings
 - ~17 meters of shoreline protected using willow fascines or coir logs

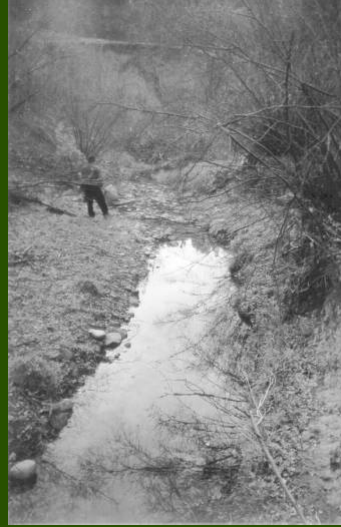
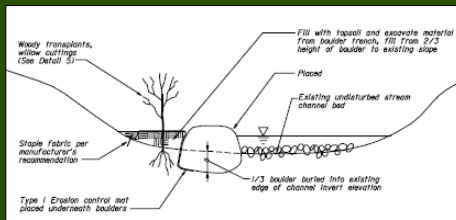
Design Details - Mitigation Wetlands

- Bank Protection
 - ~11.6 meters of shoreline protected using boulders

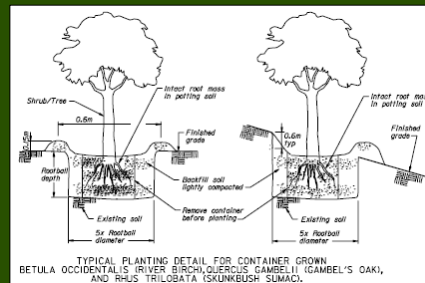
Design Details - Mitigation Wetlands

- Woody Species Plantings
 - 13 cottonwoods
 - 3 river birch
 - ~175 square meters of riparian area planted using willow cuttings
